ATR-0202 (02 February 2020)
Flight #9 and #10 – as200009 and as200010
Marie Lothon, Cyrille Flamant
Sandrine Bony, Jumien Delanoë

1. Objective

The objective of this flight is to characterize the cloud and boundary layer properties within the HALO circle, focusing on the cloud base level and the subcloud-layer. Take off was 30 min earlier, for HALO to fit to a GPM overpass (with a clover trajectory for part of its flight). TO flew SW of the ATR rectangle during [Flight #9, probing the NW corner of a flower. TO had to cancel its second flight.

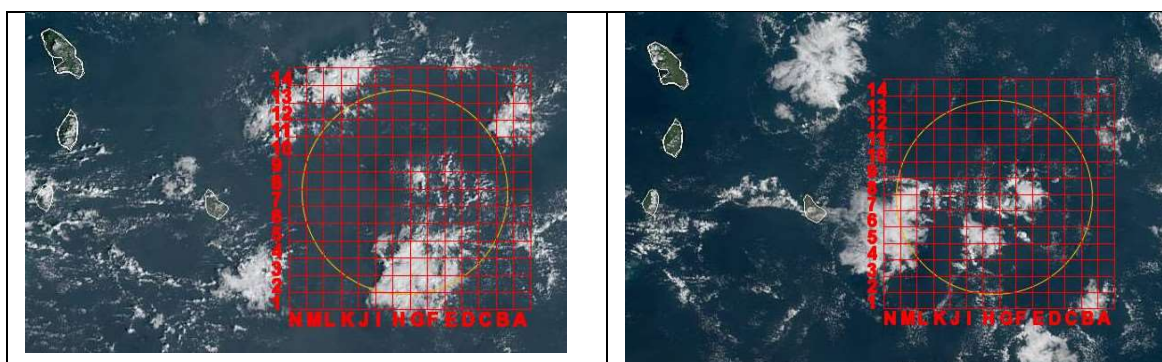
*Target area superimposed on GOES satellite picture at 12:40 UTC and 18:10 UTC.
The flower in the southern part of the circle at 12:40
has moved to the West at 18:10, on the eastern side of the circle.
Image credit from Phil Rosenberg (Leeds).*

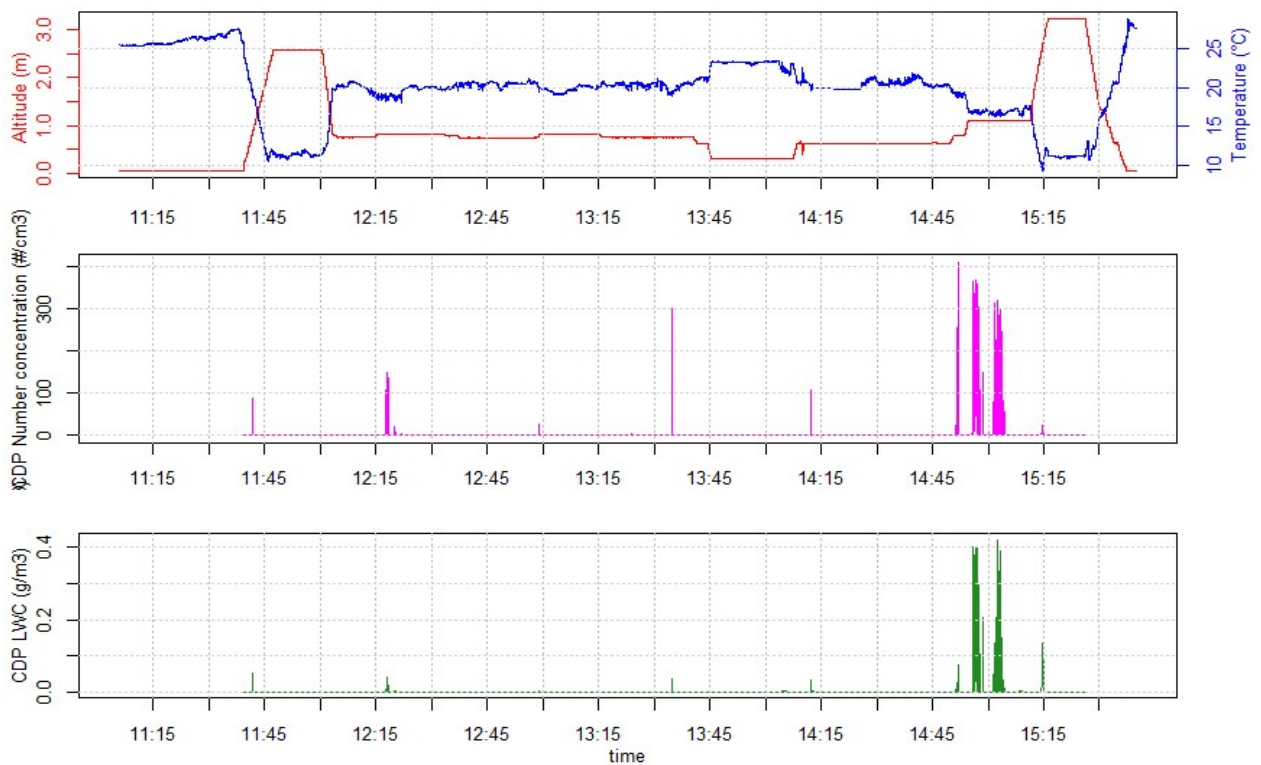
Flight 9 - 2020-02-02 - LaMP Preliminary quicklook

Time series of altitude, T, LWC, and droplet concentration during flight #9.

After the two subcloud layer L, that were done from bottom to the top, an extra L pattern was flown into the flower, SE of the rectangle. Rain and turbulence were encountered below and within the flower inflow. The final leg into the flower has been flown at 3500 ft. This leg should be used for intercomparison of microphysical properties between TO and ATR-42, knowing that TO sampled this flower at the same altitude some 20 minutes before the ATR-42. On this leg in the lower part of the flower 300-370 droplets / cm³ and 0.4-0.5 g/m³ were measured.

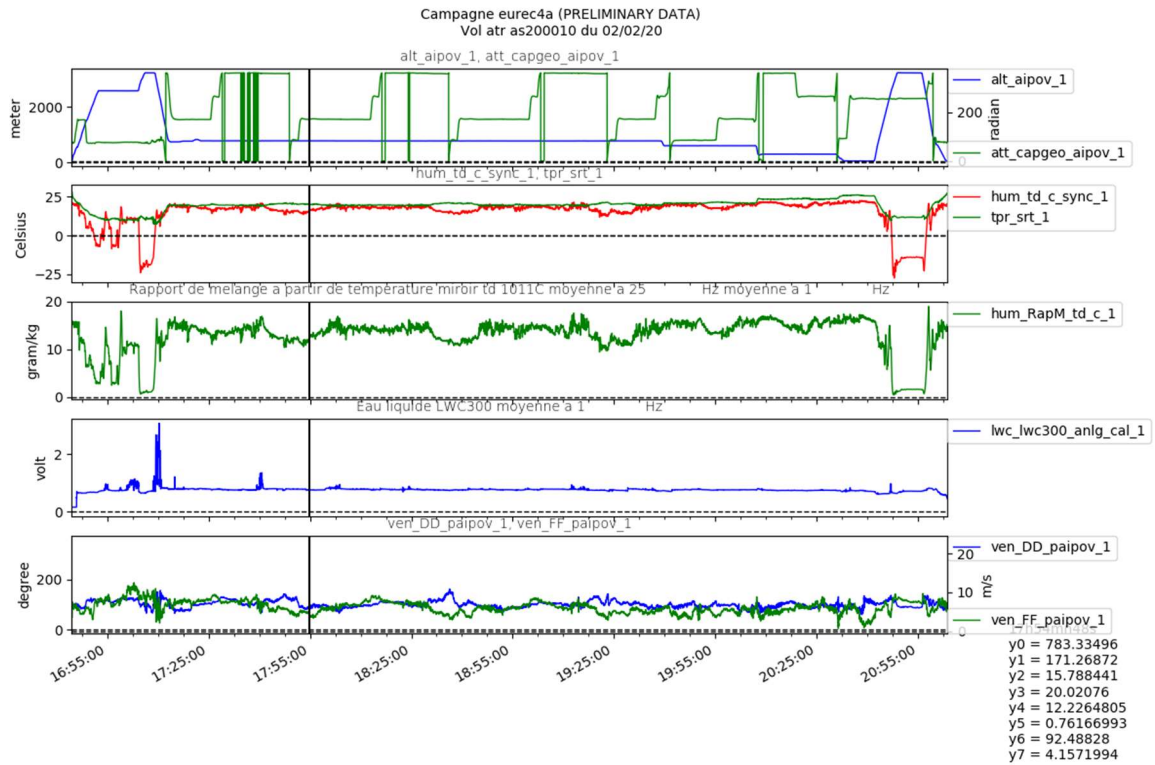
Time series during second flight of (1) altitude (blue) and heading (green), (2) Dew point temperature (red) and temperature (green), (3) water vapour mixing ratio, (4) liquid water content (uncalibrated), (4) horizontal wind speed (green) and direction (blue).
Caution: those are preliminary unvalidated data.

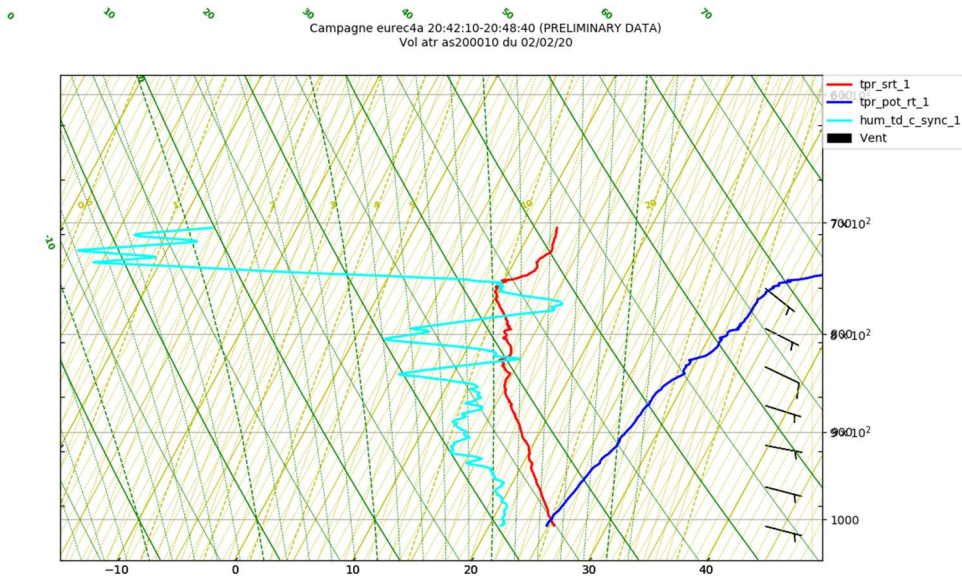
Skew-T diagramme during alinear ascent of second flight from the circle area to the ferry leg back

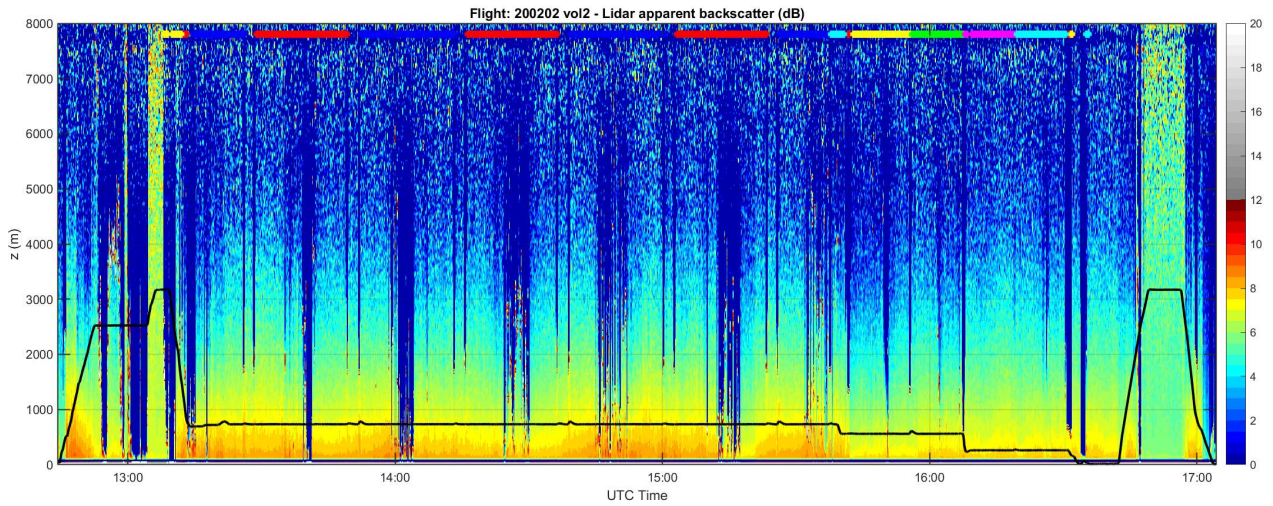
Along line of sight ALIAS backscatter signal during Flight #10. The black line at the bottom of the plot is the altitude. The color code at the top of the plot indicates the rectangle pattern (blue=aircraft heading southward, red: aircraft heading northward) and the L-pattern (yellow= aircraft heading eastward, green = aircraft heading southward, magenta= aircraft heading northward, light blue= aircraft heading westward).

Hazy conditions were encountered during Flight #9, the ALIAS lidar showing high depolarization value up to ~2 km AMSL. This was confirmed by AERONET measurements in Ragged Point (Aerosol Optical Thickness of 0.4). Upon landing, the ATR crossed an aerosol plume (black carbon) from a fire.

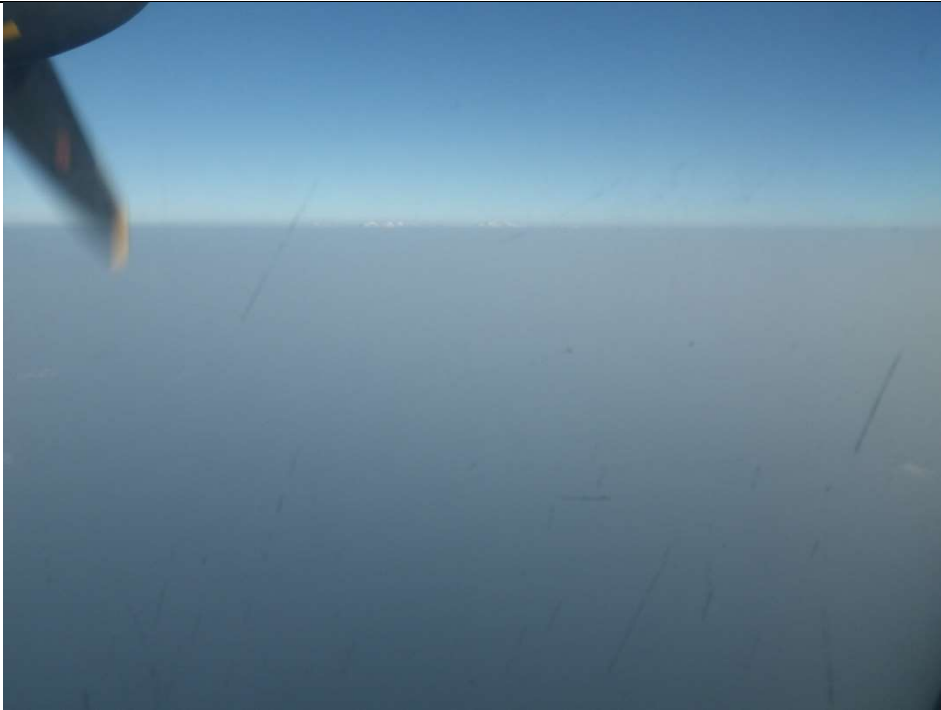
Above the dust layer on ferry flight 11:53

The dust layer is observed up to 2500 m. It induced small visibility and fuzzy (and rare) cloud base.

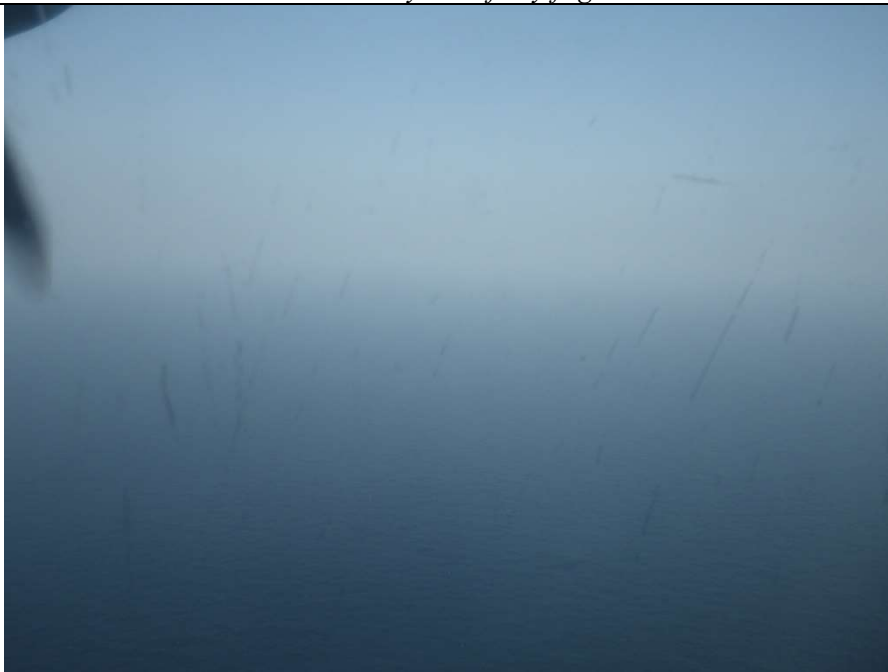
At 'cloud' base 12 :05, very fuzzy hazy layer
